# OPERATION OF A HAYNES ALLOY NO. 25 FORCED CIRCULATION LOOP TO STUDY THE EFFECTS OF HYDROGEN IN A SIMULATED SUNFLOWER SYSTEM

*by R. C. Schulze and D. B. Cooper*

Prepared under Contract No. NAS 5-462 by  
THOMPSON RAMO WOOLDRIDGE, INC.  
Cleveland, Ohio

NATIONAL AERONAUTICS AND SPACE ADMINISTRATION • WASHINGTON, D. C. • MAY 1965

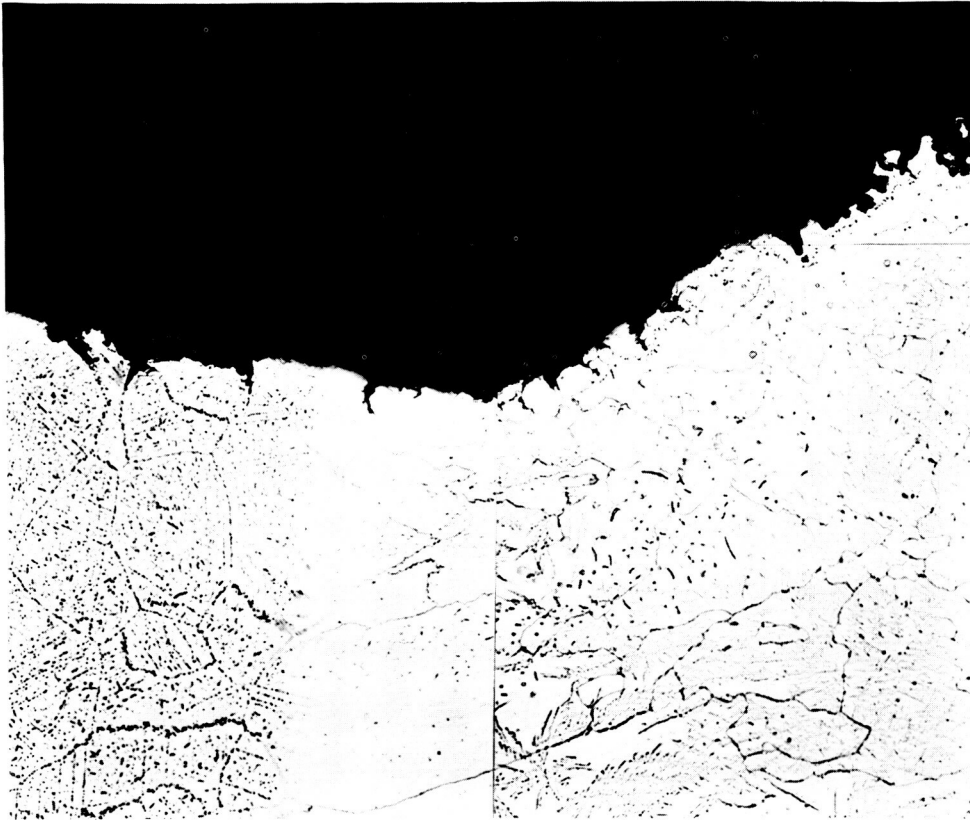
Figure 31. Appearance of Corrosive Attack Found on the I.D. Surface of the Specimen Removed from the Weld in the Lower Part of the Boiler Inlet (Section No. 11, Weld).

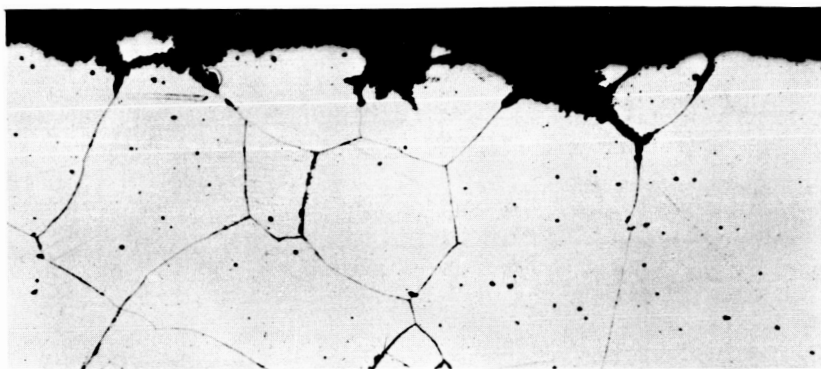
Along with the attack, deposits of corrosion products were found along the tube wall within the superheater. These deposits were metallic in appearance and appeared to be metallurgically bonded to the inside surface of the tubing. The greatest amount was found in the superheater inlet (Section 20 and 20A). Section 20A was removed after 3833 hours so that the crud separator could be installed in the superheater. Figure 38 (Section 20, thermocouple SH 1) shows the general appearance of the deposit at 100 magnification. In this region, the deposit was rather uniform in nature as shown in Figure 39 (macrograph of a portion of Section 20). The thickness of the deposit varied from 0 to .03 in. in depth.

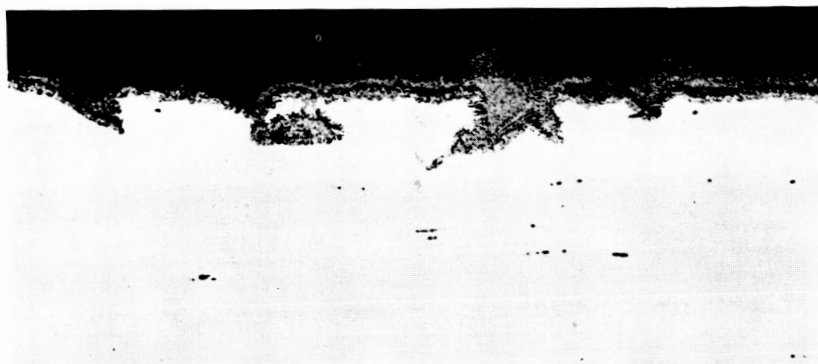
Figure 34. I.D. Surface of Specimen Removed from the Lower Part of the Boiler Outlet (Section No. 15, Thermocouple No. 10).

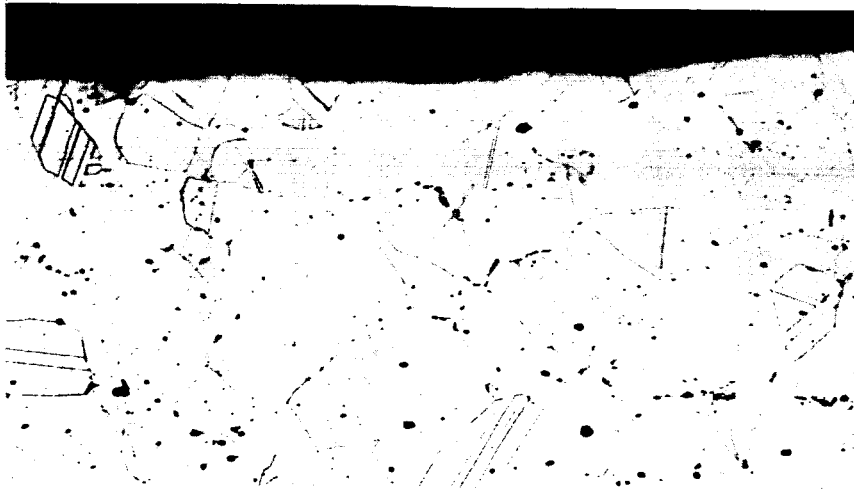
The results of the examination of the specimens removed from the condenser region are shown in Table 13. As shown, the attack found was limited to a light pitting to a maximum depth of 0.0005 in. Figure 43 (Section No. 29, thermocouple No. 35) shows the general appearance of the type of attack found. A weld area in the condenser was also examined for any possible attack. The area examined was in Section No. 27 where the condenser tubing was reduced in size from 5/8" O.D. to 1/2" O.D. tubing. As was the case with the rest of the welds examined, the weld appeared sound.

Figure 43. Appearance of the I.D. Surface of the Specimen Removed From the Condenser (Section No. 29, Thermocouple No. 35).

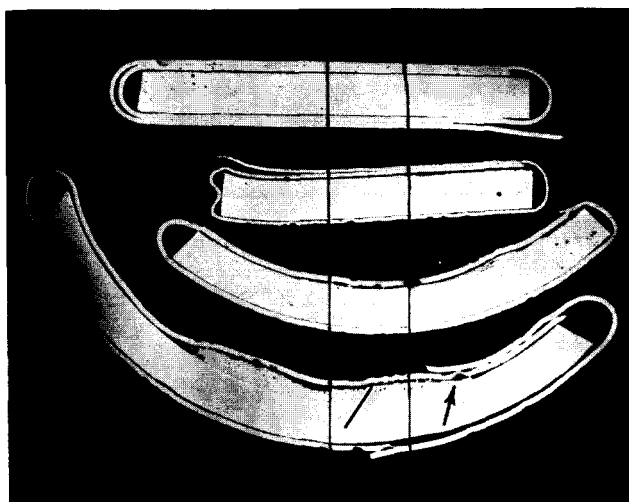
As a further study of the amount of corrosion incurred by the loop, electron beam microprobe analyses were conducted on four of the metallographic specimens. The analytical work was conducted by Advanced Metal Research Corp. Two of the specimens (Section No. 16, thermocouple No. 11; and Section No. 17, thermocouple No. 13) were from the boiler outlet region. The other two (Section 20A, thermocouple No. 18 and Section No. 22, thermocouple No. 21) were from the inlet and middle regions of the superheater, respectively. Two separate areas on the specimen Section No. 20A, thermocouple No. 18 were analyzed. Figure 45 shows the approximate location and scan paths made on the specimens.

Figure 45. Macrograph of Mount Showing the Location of the Microprobe Scan Analyses. Except for the one area marked by the arrow, the rest of the analyses were conducted within the area bounded by the two scratch marks. The line on the bottom specimen indicates the orientation of the scan trace.

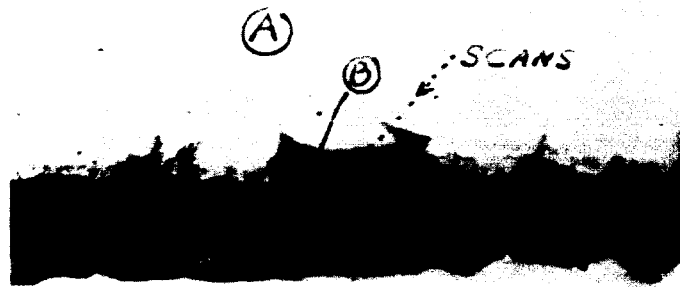
Figure 46. I.D. Surface of Specimen Removed from Section No. 16, Thermocouple No. 11, Showing the Microprobe Scan Path and Areas Analyzed.

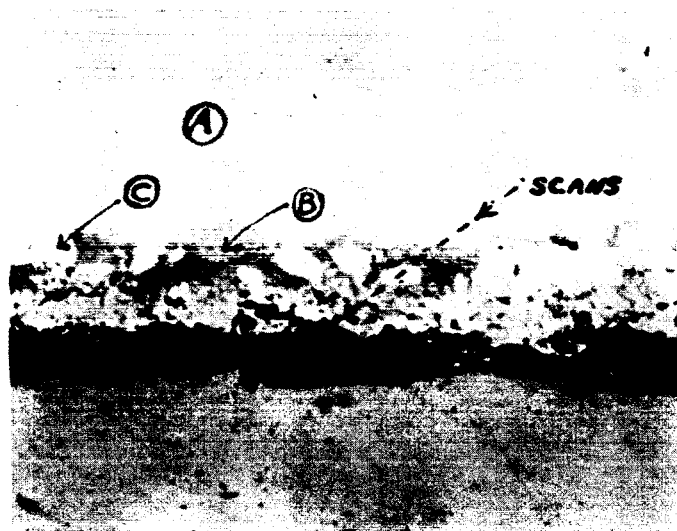
The analyses conducted on the two specimens from the boiler outlet region support the results obtained on wet chemical analysis of the deposits removed from the inside tube wall. However, three different compositional areas were found in the deposit along the surface of specimen Section No. 17, thermocouple No. 13. The grayish appearing phase is similar in composition to the corrosion layer found along the surface of the specimen Section No. 16, thermocouple No. 11 (Figure 46). As shown in Table 18, this phase is high in cobalt and tungsten with only small amounts of chromium and nickel. The white areas (marked C in Figure 47) within the deposit were found to be essentially the base metal depleted of chromium, whereas the edge of the deposit (marked B in Figure 47) was found to be essentially base material depleted in tungsten and nickel.

Figure 47. I.D. Surface of Specimen Removed from Section No. 17, Thermocouple No. 13, Showing the Microprobe Scan Path and Areas Analyzed.

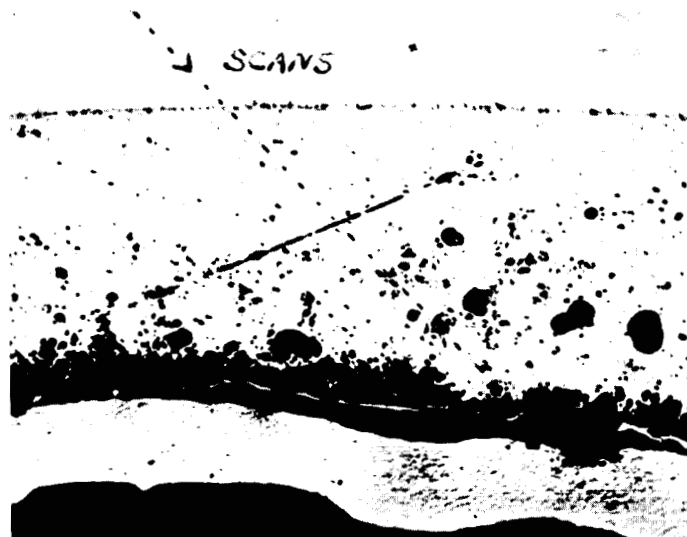
Figure 48. I.D. Surface of Specimen Removed from Section No. 20A, Thermocouple No. 18, Showing the Microprobe Scan Path.

Two areas of different composition were found within the deposit on the specimen Section No. 20A, thermocouple No. 18. As shown in Table 18, the bulk of the deposit (Figure 48 and marked C in Figure 49) was predominantly nickel with about 25 to 27 percent chromium. Only minor amounts of tungsten, iron and cobalt were found. However, another phase, (marked B in Figure 29) was found that was almost pure chromium (98-99 percent). Cobalt, tungsten, iron and nickel were found only in small or trace amounts. The results of the analysis of the specimen Section No. 22, thermocouple No. 21 were approximately the same. However, the chromium-rich phase was present in a greater quantity within the deposit. Also, there was not the same amount of distinction between the phases as was found in the specimen Section No. 20A, thermocouple No. 18.

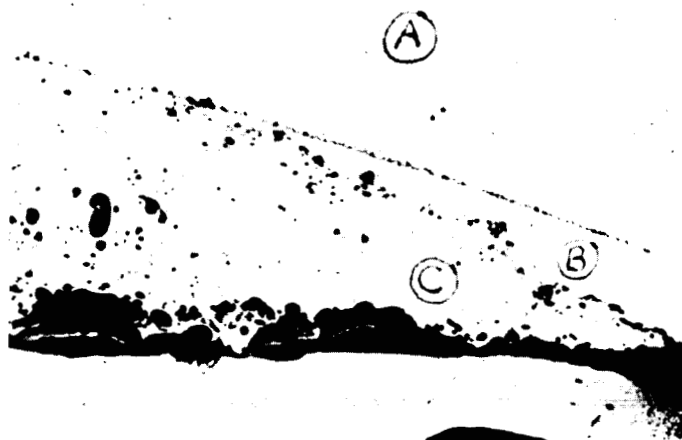
Figure 49. I.D. Surface of the Specimen Removed from Section No. 20A, Thermocouple No. 18, Showing the Areas Analyzed. This area is the area marked by the arrow in Figure 45.

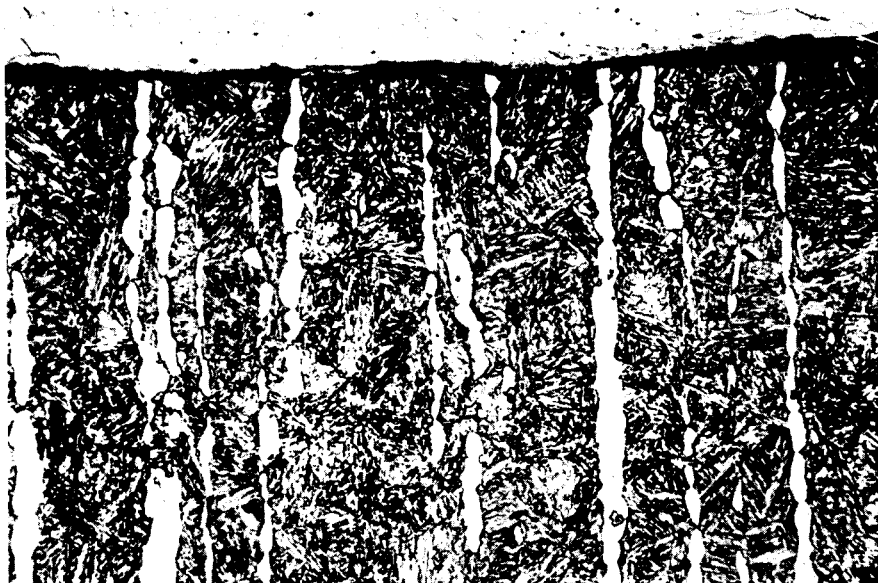
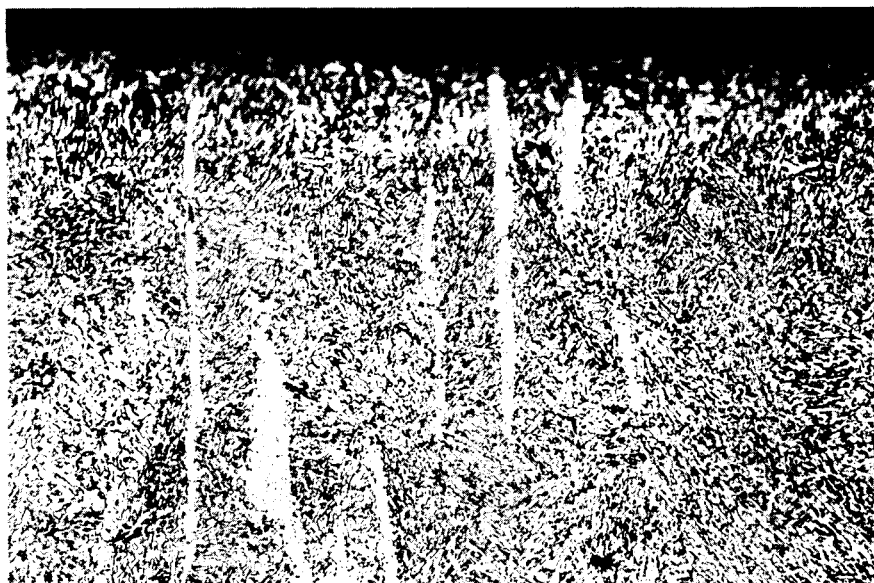
Figure 52 shows before and after test photomicrographs of the PH15-7Mo erosion specimen heat treated to the RH 950 condition. As shown by the photomicrographs, the edge of the specimen was relatively unaffected by the exposure to high velocity mercury vapor. However, as can be seen, the microstructure of the specimen in the after test condition changed from an acicular martensitic structure to that of a tempered martensite. Also as shown, carbon diffused into the ferrite stringers.

Figure 52. Condition of the Edge of the PH15-7Mo Erosion Specimen Heat Treated to the Condition RH 950.

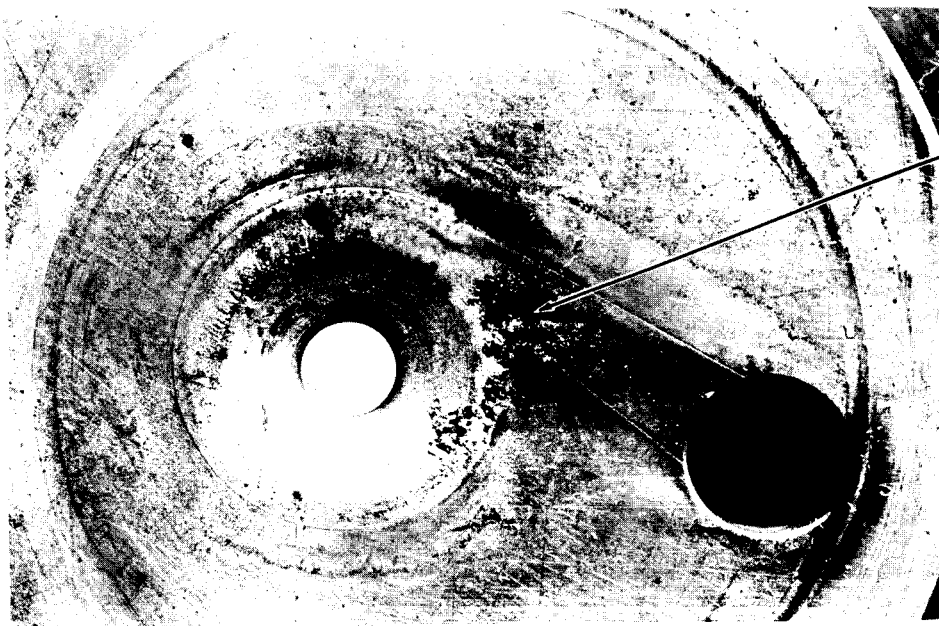
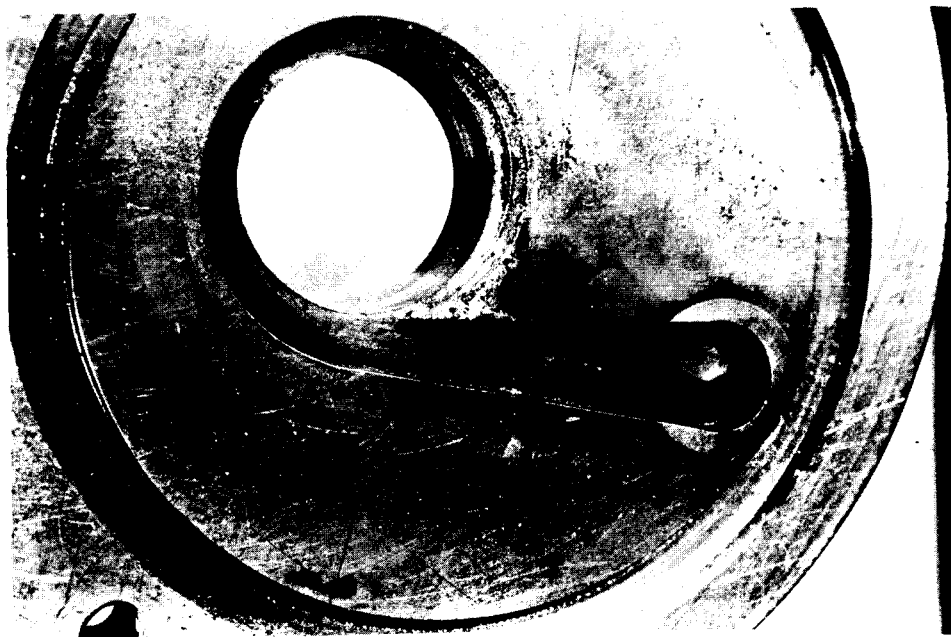
The final loop component to be examined was the centrifugal pump, which was fabricated from Type 316 stainless steel. The pump head was dismantled and examined visually for any possible damage. The pump components examined are shown in Figure 55. Evidence of cavitation damage was found only on the volute tongue. Figure 56 shows macrographs of the tongue and the extent of damage incurred. Sections were removed from the top part of the tongue (Figure 56) at the damaged area. These sections were then mounted and polished for metallographic examination.

Area where metallographic specimen was removed.

Figure 56. Macrograph of Centrifugal Pump Body Showing the Extent of Damage Incurred.

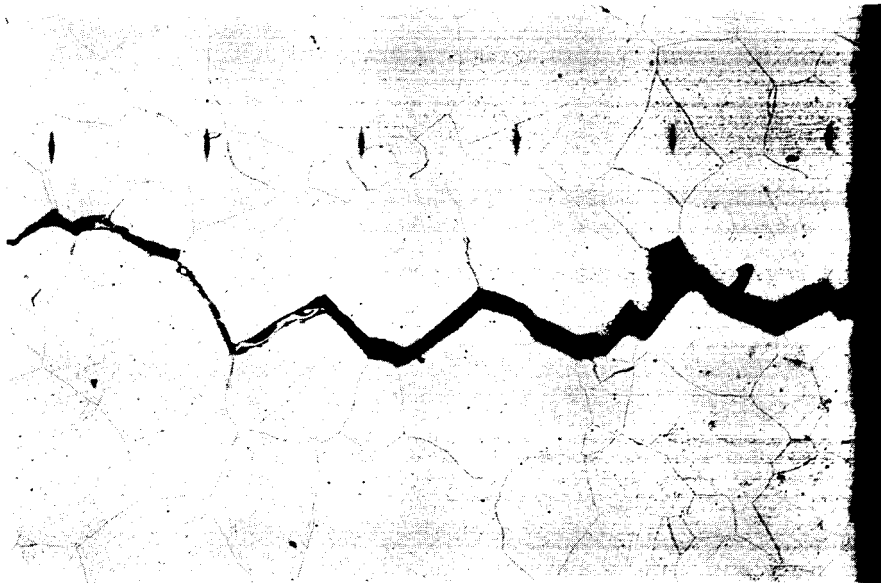
Figure 59 shows the general appearance of the crack in the tube wall. As can be seen, the crack is intergranular in nature. Also, along the crack, smaller cracks were found extending into the grain boundaries from the failed surface. The mode of failure appears to be a brittle type of fracture.

Because of the configuration of the superheater, it was impossible to anneal the tubing after fabrication. Also, the temperature of this region before the failure was about 1400°F. Considering the temperature and cold-worked condition of the tubing, there is the possibility that the tubing in this region was embrittled. Previous investigations on Haynes alloy No. 25 have shown that the alloy has a tendency to embrittle rapidly if exposed to elevated temperatures in the cold-worked condition (1).

Figure 59. Appearance of the Crack Found in the Tube Wall of the Superheater After 262 Hours of Operation.

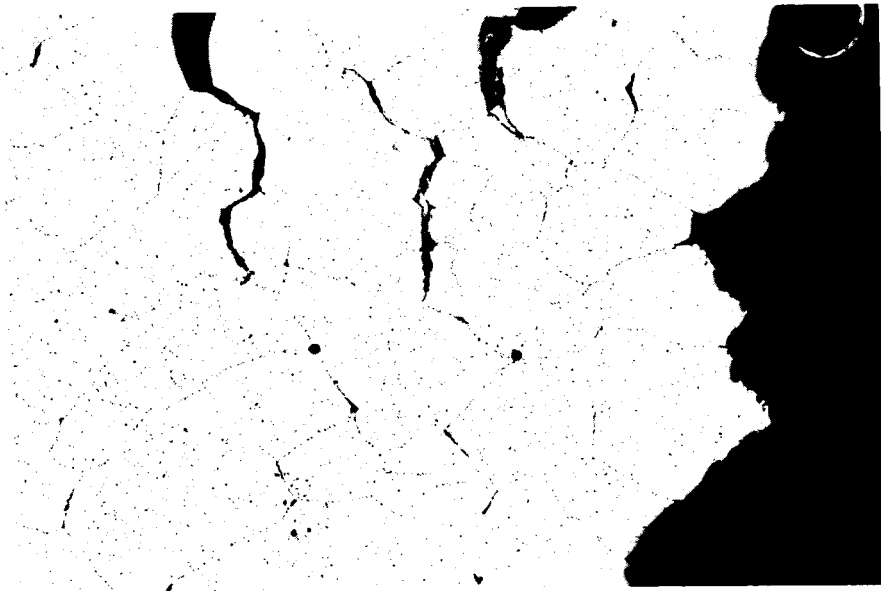
Again, metallographic specimens were removed at the point of failure as well as on either side of the failure. The location of the specimens removed is shown in Figure 11. The crack was again intergranular in nature as shown in Figure 61. However, in this case, the tube wall near the crack was necked down. Also, numerous cracks were found along both the I.D. and O.D. surfaces as well as within the tube wall. The crack density was greatest within the necked down area. The appearance of the tube wall in this case points to a creep rupture type of failure. The appearance and mode of failure indicate that the tube wall was locally overheated and that the rupture may have been the result of a pressure overload at the local thermal condition.

Figure 61. Appearance of the Tube Wall of the Boiler Showing the Failure which Occurred After 3876 Hours.

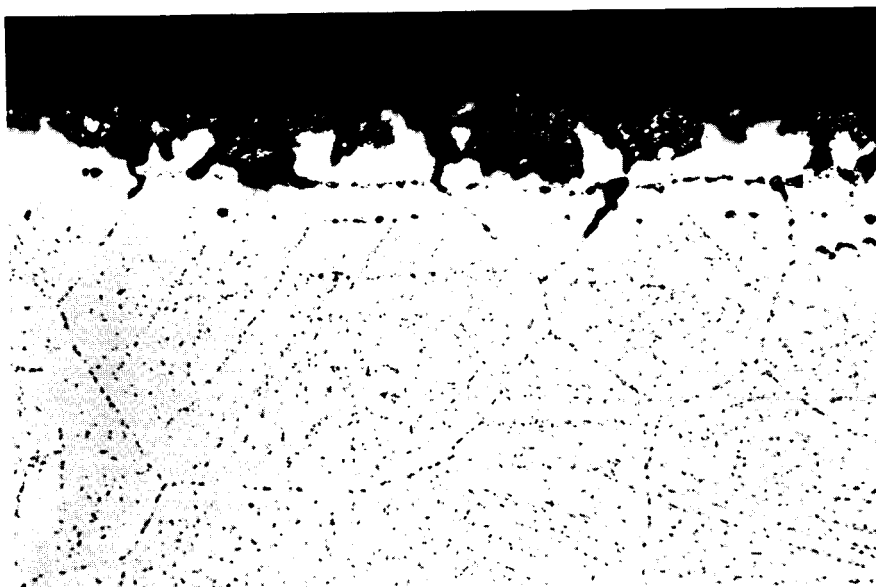
In addition to the cause of failure, the specimens were also examined for the extent of corrosive attack found. In general, the I.D. surface on each specimen was found to have undergone a combination of layer, crevice, and depletion attack to a maximum depth of 0.003 inch. Figure 62 is typical of the corrosive attack found. Examination of the surface of the specimen removed from the inlet end of the section revealed a deposit about 0.015 in. thick. Figure 63 shows the appearance of the deposit. Unfortunately, there was not enough deposit present in the section of tubing to obtain an analyses.

Figure 62. Appearance of the I.D. Surface Near the Failure which Occurred in the Boiler After 3876 Hours.

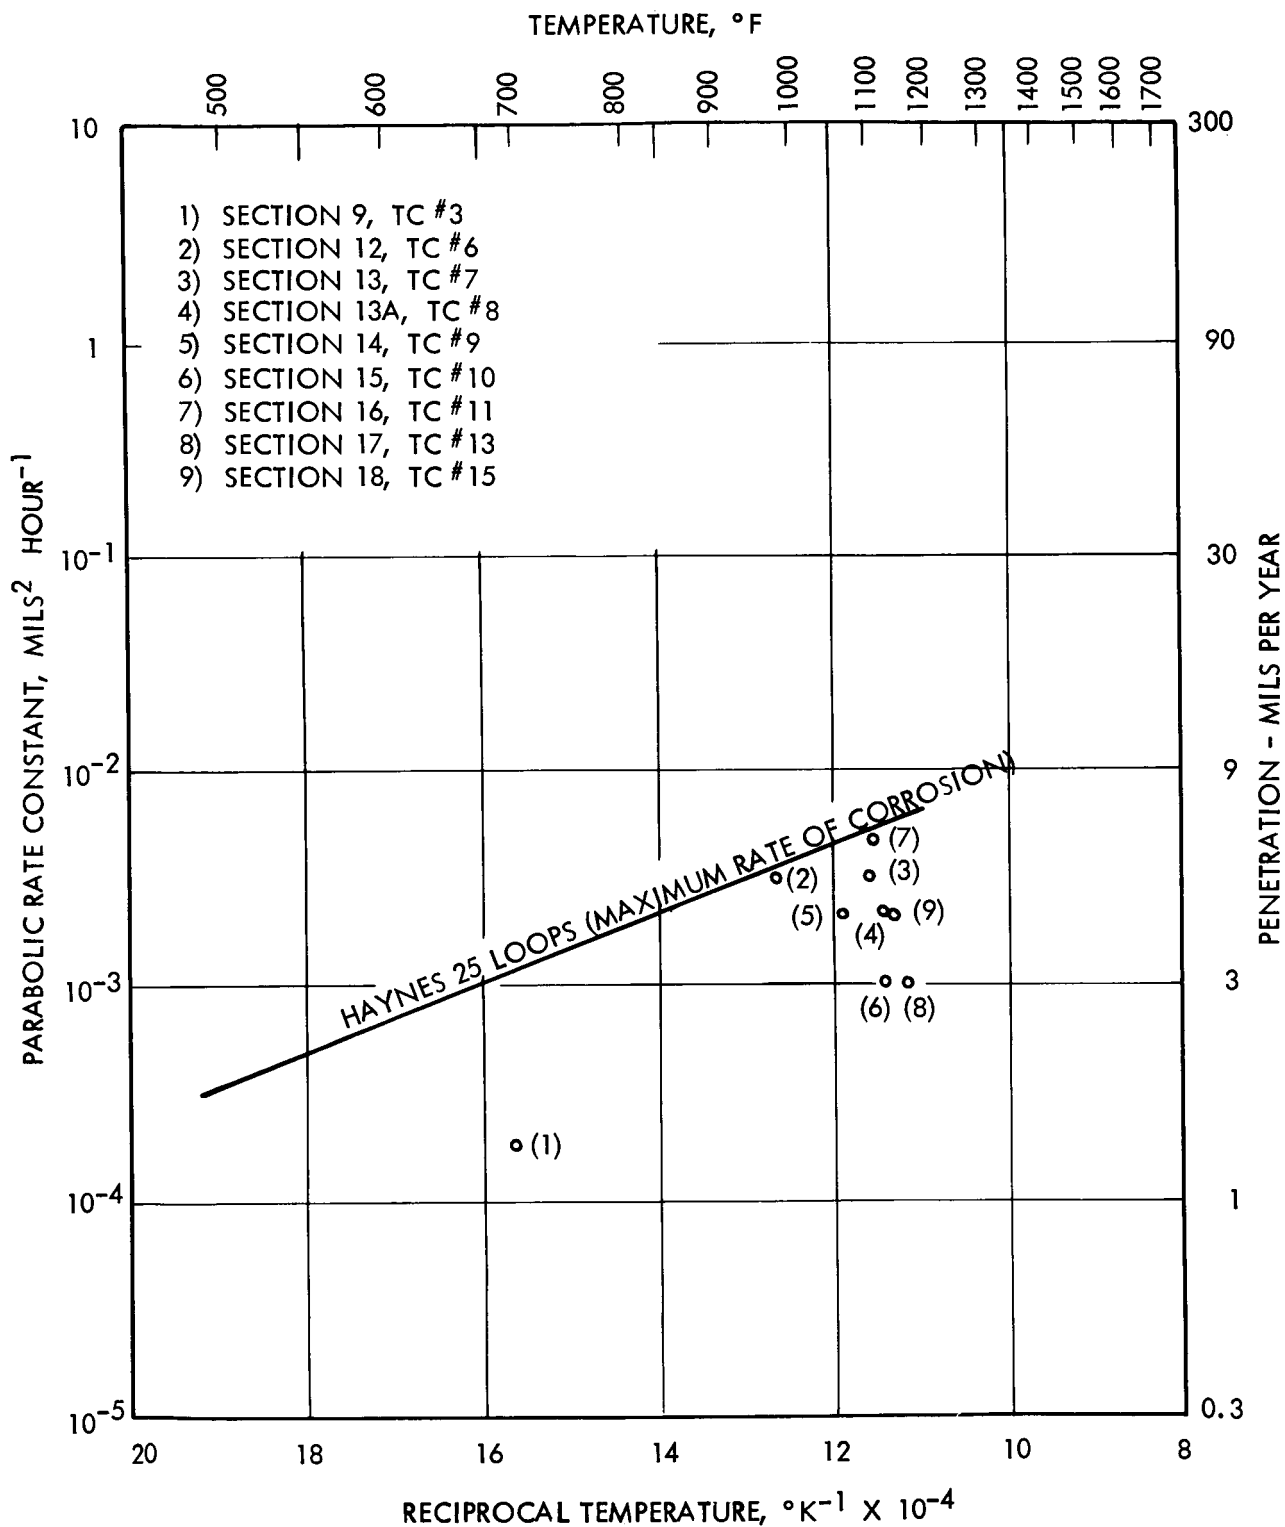
In general, the depth and mode of corrosion incurred in the boiler regions compare favorably with results obtained from previous corrosion tests. As shown in Figure 65, the attack incurred has been plotted as a function of the temperature. The results as plotted fall below or near to the curve, which is the maximum expected corrosion rate plotted as a function of the temperature (3).

However, the data, as plotted, should be used only for comparative purposes. As discussed with the results on metallographic examination, the temperatures listed for the various specimens are not truly representative of the total operating life. In view of this, the results seem to confirm the previous data on the corrosion of Haynes alloy No. 25 as obtained from thermal convection loops and capsule tests (2) (4).

FIGURE 65 COMPARISON OF HAYNES ALLOY NO. 25 MERCURY PENETRATION FROM THE WORK HORSE LOOP WITH TWO-PHASE THERMAL CONVECTION LOOPS
